National Institute of Standards and Technology

National Institute for Standards and Technology (NIST), er en institution i USA, der svarer til Teknologisk Institut i Danmark. Efter terrorangrebet den 11. september 2001 fik NIST til opgave at undersøge de bygninger i World Trade Center, der blev ødelagte som følge af angrebet. Formålet med undersøgelserne var at komme med forebyggende forslag og standarder til bygge- og anlægsbranchen, så ulykker kunne undgås i fremtiden og brandbekæmpelse kunne forbedres.

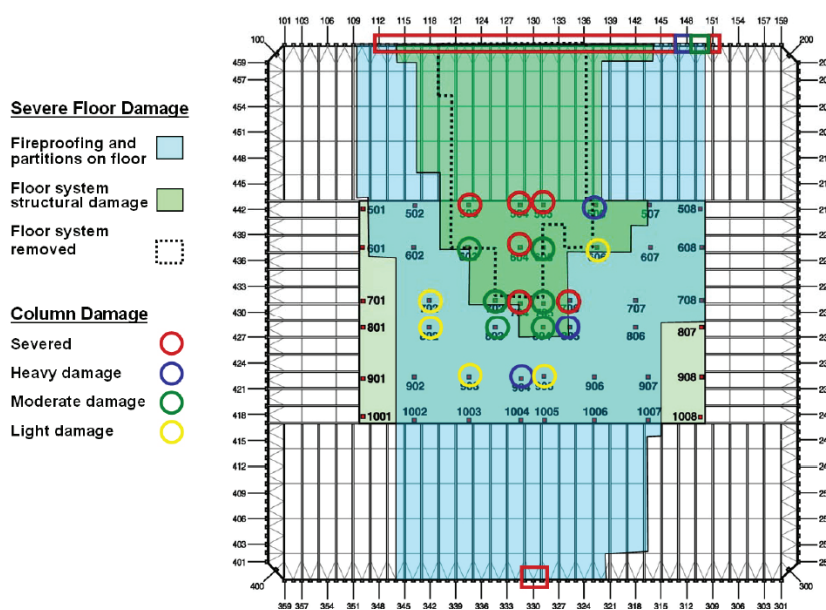
Figure 2-4. Simulation of cumulative aircraft impact damage to floors 93 through 98 in WTC 1.

- The aircraft impact severed a number of exterior columns on the north wall from the 93rd to the 98th floors, and the wall section above the impact zone moved downward.

- After breaching the building's perimeter, the aircraft continued to penetrate the building, severing floor framing and core columns at the north side of the core. Core columns were also damaged toward the center of the core. Insulation was damaged from the impact area to the south perimeter wall, primarily through the middle one-third to one-half of the core width. Finally, the aircraft debris removed a single exterior panel at the center of the south wall between the 94th and 96th floors.
