National Institute of Standards and Technology

National Institute for Standards and Technology (NIST), er en institution i USA, der svarer til Teknologisk Institut i Danmark. Efter terrorangrebet den 11. september 2001 fik NIST til opgave at undersøge de bygninger i World Trade Center, der blev ødelagte som følge af angrebet. Formålet med undersøgelserne var at komme med forebyggende forslag og standarder til bygge- og anlægsbranchen, så ulykker kunne undgås i fremtiden og brandbekæmpelse kunne forbedres.

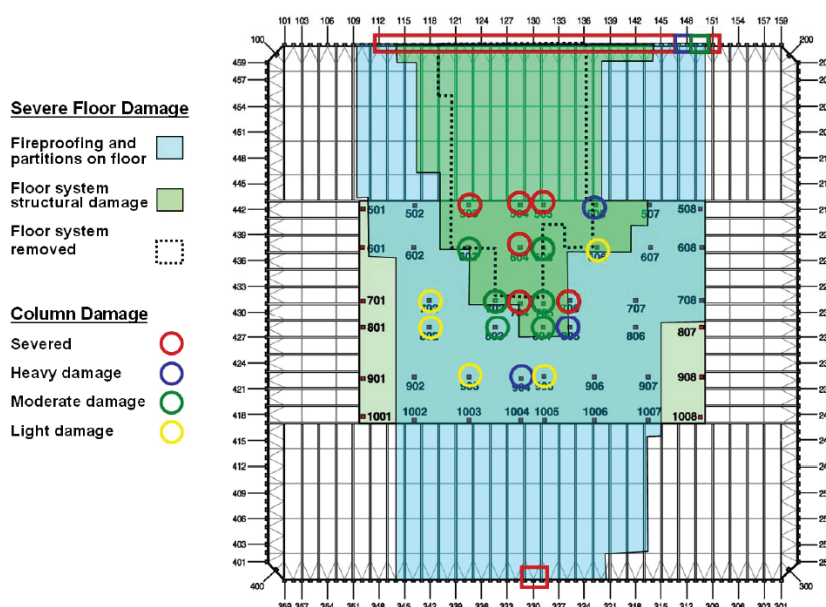
Figure 2-4. Simulation of cumulative aircraft impact damage to floors 93 through 98 in WTC 1.

- After breaching the building's perimeter, the aircraft continued to penetrate the building, severing floor framing and core columns at the north side of the core. Core columns were also damaged toward the center of the core. Insulation was damaged from the impact area to the south perimeter wall, primarily through the middle one-third to one-half of the core width. Finally, the aircraft debris removed a single exterior panel at the center of the south wall between the 94th and 96th floors.
