## National Institute of Standards and Technology

## Hvad var den formodentlige kollapssekvens for WTC 2?

### 6.14.7 Probable WTC 2 Collapse Sequence

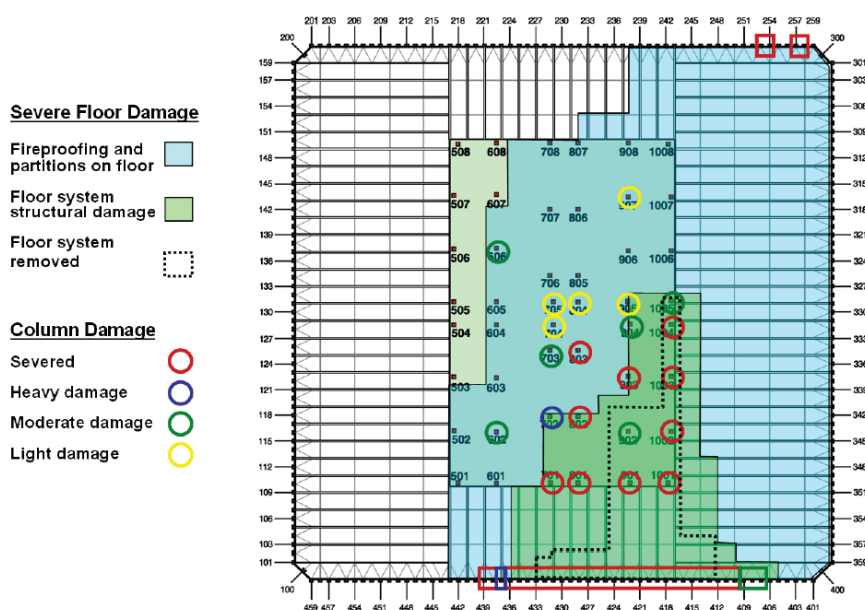
Figure 3-3. Simulation of aircraft impact damage to the 78<sup>th</sup> through 83<sup>rd</sup> floors in WTC 2.

- The aircraft impact severed a number of exterior columns on the south wall from the 78th floor to the 84th floor, and the wall section above the impact zone moved downward.

- After breaching the building's perimeter, the aircraft continued to penetrate into the building, severing floor framing and core columns at the southeast corner of the core. Insulation was damaged from the impact area through the east half of the core to the north and east perimeter walls. The floor truss seat connections over about one-fourth to one-half of the east side of the core were severed on the 80th and 81st floors and over about one-third of the east perimeter wall on the 83rd floor. The debris severed four columns near the east corner of the north wall between the 80th and 82nd floors.
