National Institute of Standards and Technology

Konklusion

NCSTAR 1-9 Vol 1 Chapters 1 - 8, side 290

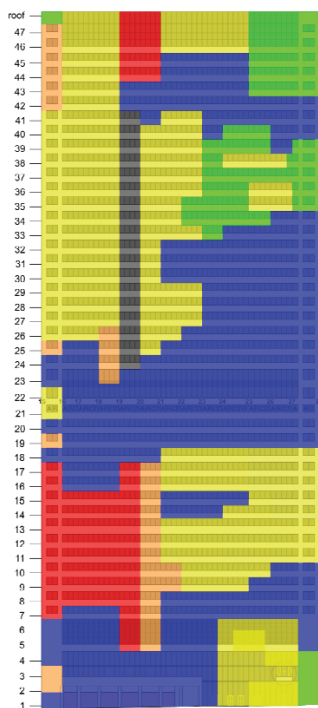
Figure 5-83. Observed damage on the south face of WTC 7 following the collapse of WTC 1.

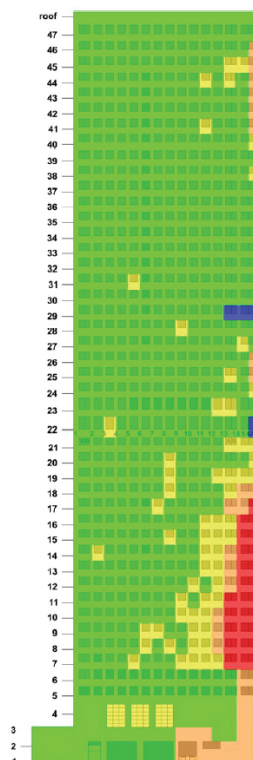
Figure 5-89. Observed damage on the west face of WTC 7 following the collapse of WTC 1 is shown.

Damage is color coded as follows: green (■) – no visible damage, yellow (■) – window glass broken out, orange (■) – granite and underlying truss damage, and red (■) – damage to outer-perimeter structural steel, and blue (■) – not visible.
