## National Institute of Standards and Technology

## Konklusion

I forbindelse med undersøgelserne, der skulle fastslå årsagerne til at de syv bygninger i World Trade Center komplekset blev ødelagte, afdækkede NIST systematisk alt tilgængeligt materiale, herunder de mange videoer, der optog Bygning 7s kollaps. NIST kunne i 2007 konkludere, at Bygning 7 kollapsede progressivt, og at kollapseet tog mindst 13.5 sekunder.

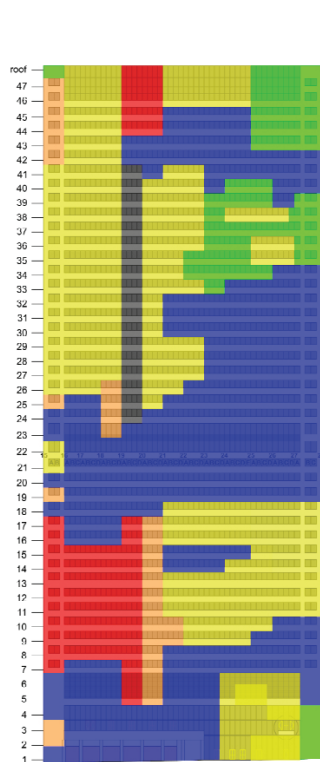
Figure 5-83. Observed damage on the south face of WTC 7 following the collapse of WTC 1.

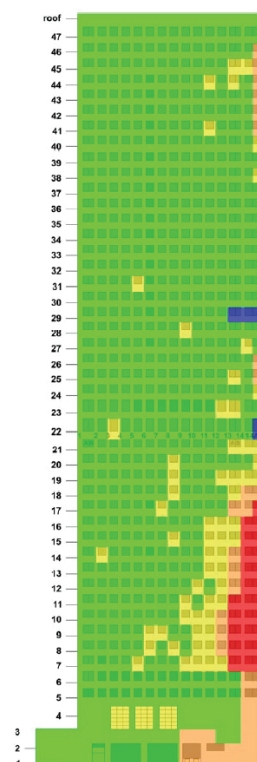
Figure 5-89. Observed damage on the west face of WTC 7 following the collapse of WTC 1 is shown.
